Tree Survey and Arborist Report for TR38237

an Approximate 9.4-acre Site on the NE C/O Oliver St. and Brodiaea Ave.

In the City of Moreno Valley, County of Riverside, California

Report Date: July 11, 2022

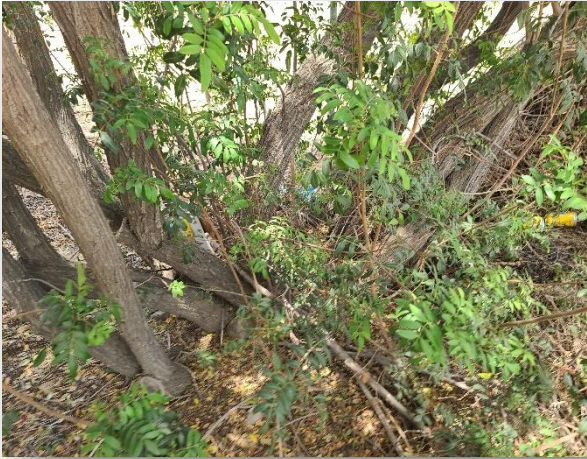
Plate 1. This is a view of a multi- stem configuration (#358).

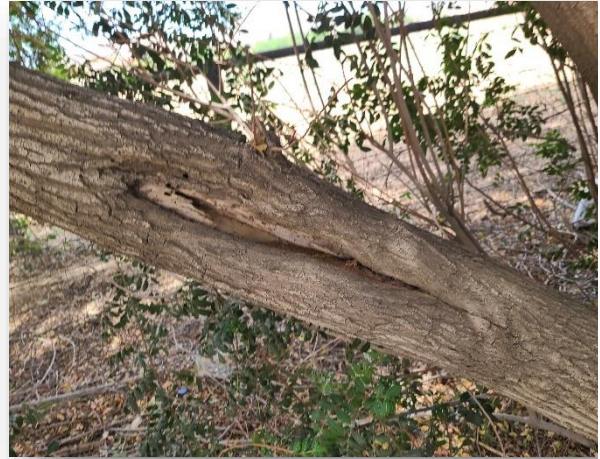
Plate 2. This is a view of a large canker with bore holes (#359).

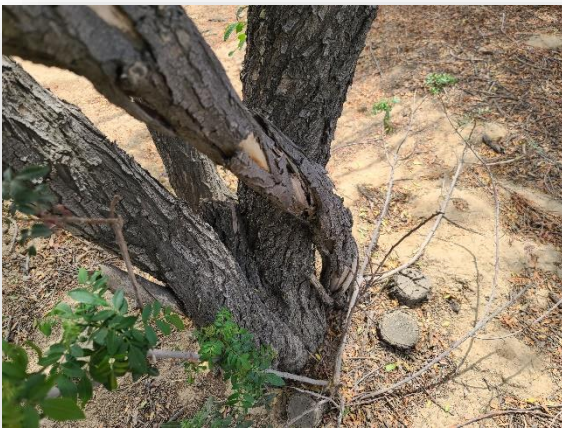
Plate 3. This is a view of a dead, diseased limb (#361).

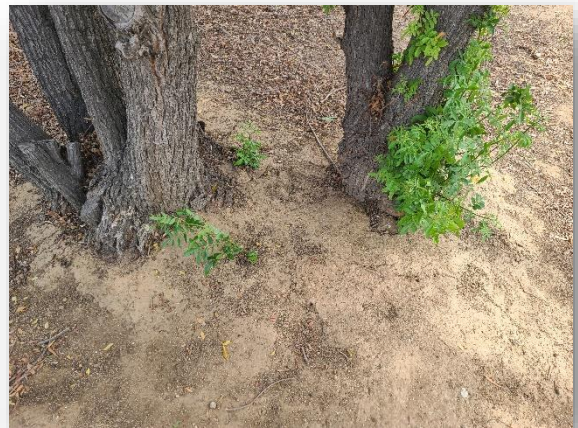
Plate 4. This is a view of mature rhizomous volunteer sprouter that resulted in competing canopies above (#375).

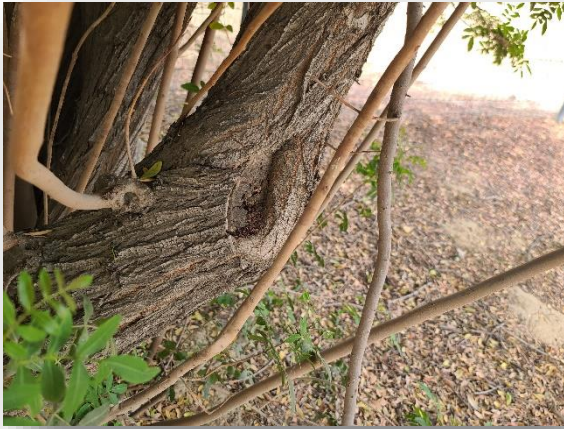
Plate 5. This is a view of an unclosed scar from an improper cut (#363).

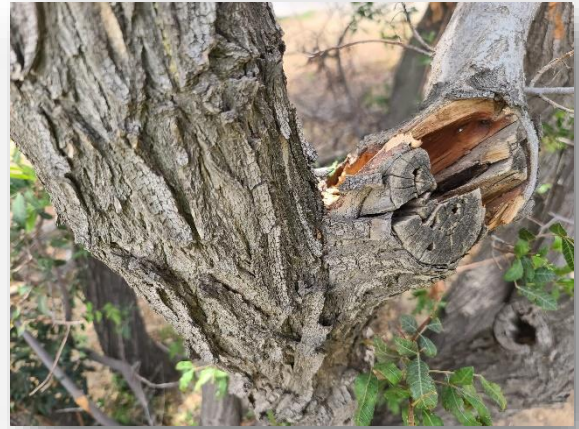
Plate 6. This is a view of bore holes within a branch cut (#365).

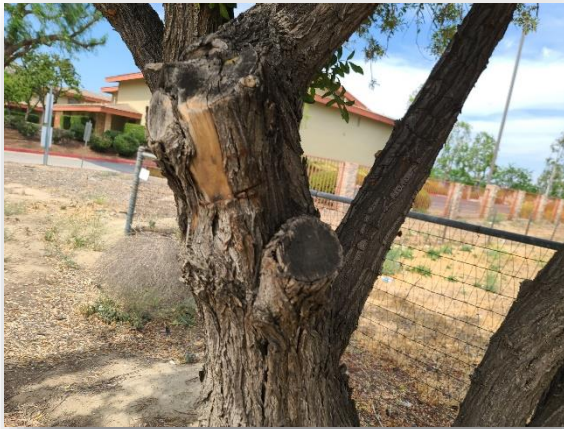
Plate 7. This is a view of diseased wood resulting from poor pruning (#376).

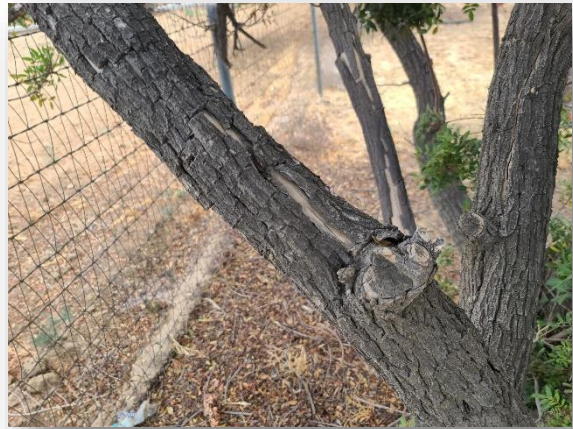
Plate 8. This is a view of diseased tissue on a primary stem (#368).

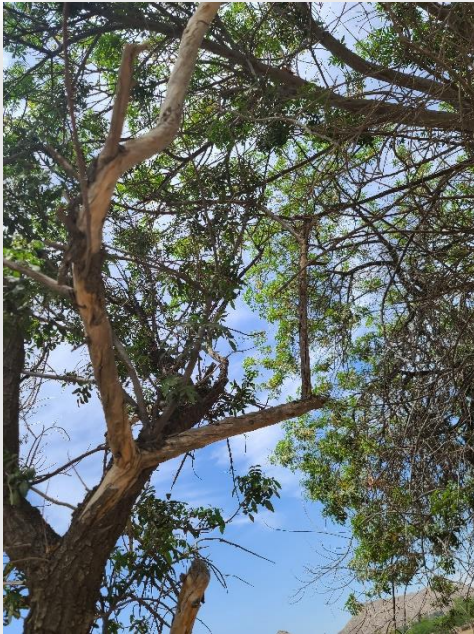
Plate 9. This is a view of a diseased limb within a canopy (#361).

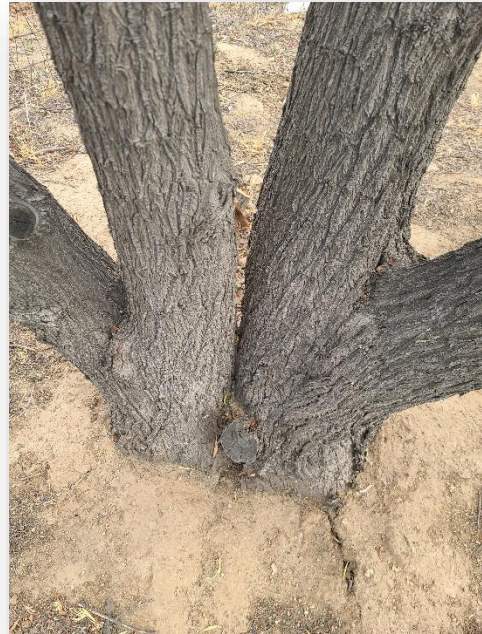
Plate 10. This is a view of included bark within the crotch of two primary stems (#372).

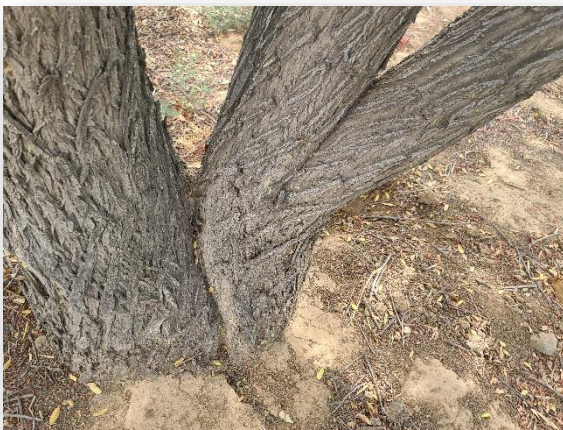
Plate 11. This is view of included bark within the crotch of a primary stem and limb (#369).

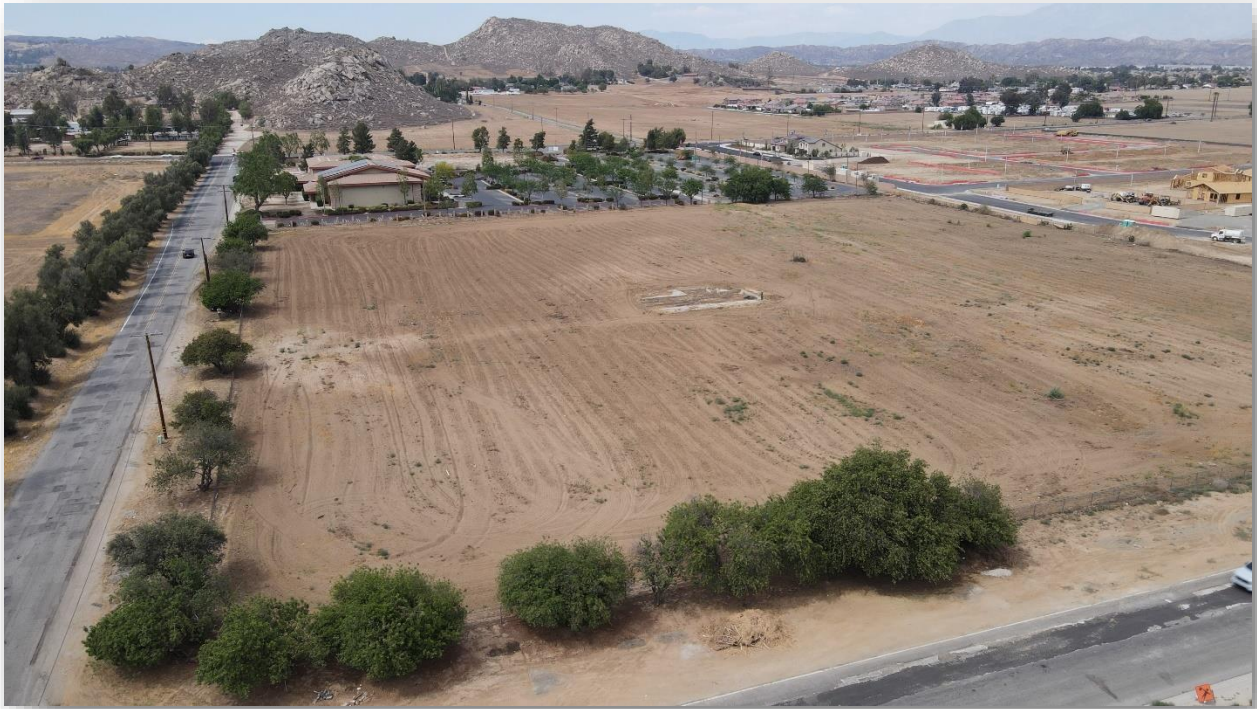
Plate 22. This is an northern aerial view near the southern boundary of the site illustrating the windrow of planted trees within the project area as well as the disturbed soil.
