Moreno Valley Business Park Building 5

Moreno Valley Specific Plan No. 205
Amendment No. 2

Initial Study

July 2023

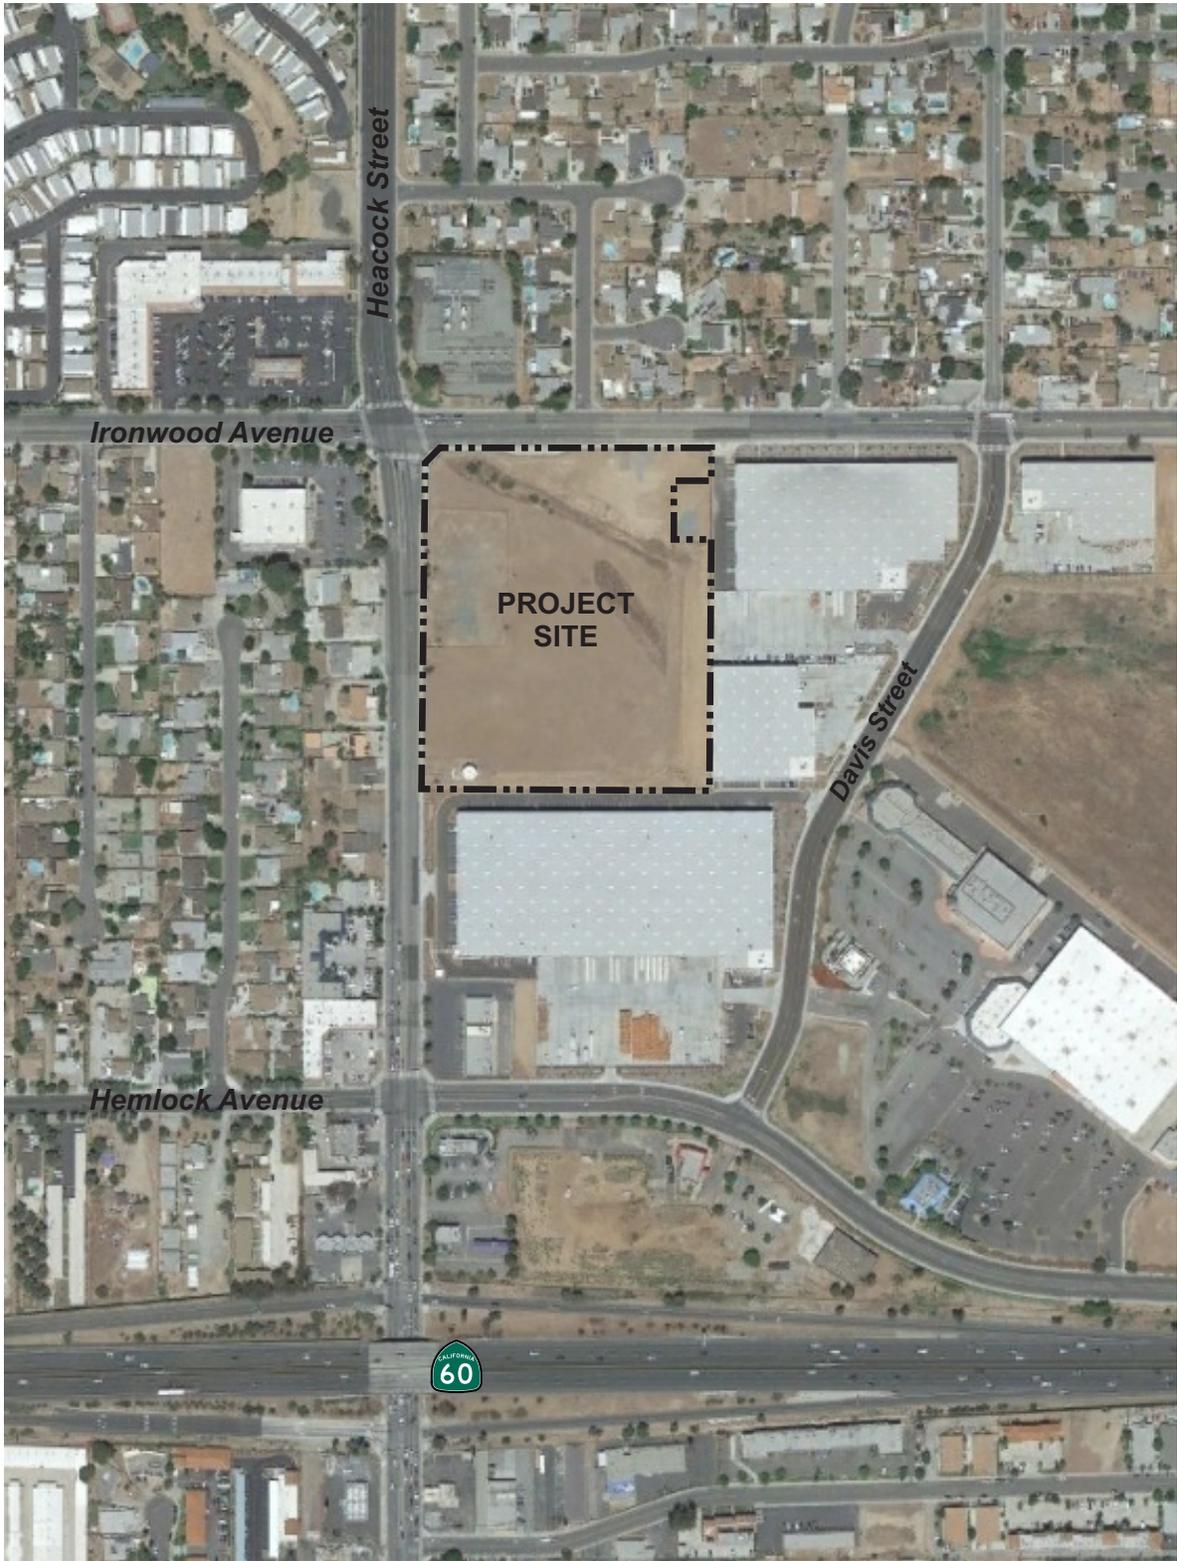
Figure 2.2-1
Project Location

NOT TO SCALE
Source: Google Earth; Applied Planning, Inc.

Specific Plan No. 205 is located north of SR-60 (E – W) at Heacock Street (N – S) in the northwest portion of the City of Moreno Valley, in western Riverside County. The Project considered herein comprises approximately 9.98 acres within Specific Plan No. 205, located immediately southeast of Ironwood Avenue (E – W) at Heacock Street (N – S). Please refer to Figure 2.2-1, *Project Location*.

Specific Plan No. 205 is located northwest of SR-60 (E – W) at Heacock Street (N – S) in the northwest portion of the City of Moreno Valley, in western Riverside County. The Project considered herein comprises approximately 9.98 acres within Specific Plan No. 5, located immediately southeast of Ironwood Avenue (E – W) at Heacock Street (N – S). Please refer to Figure 2.2-1, *Project Location*.

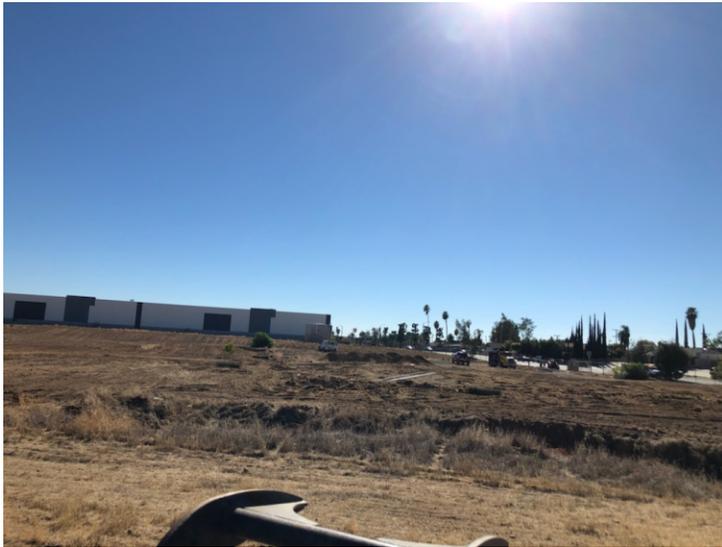
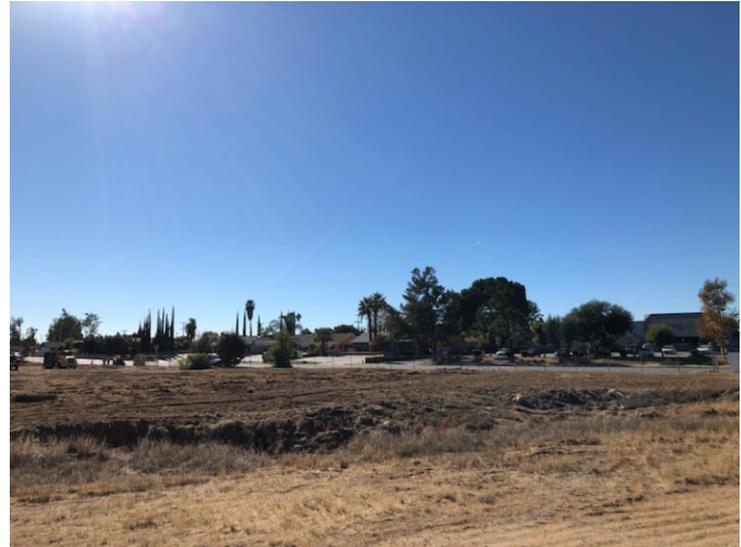
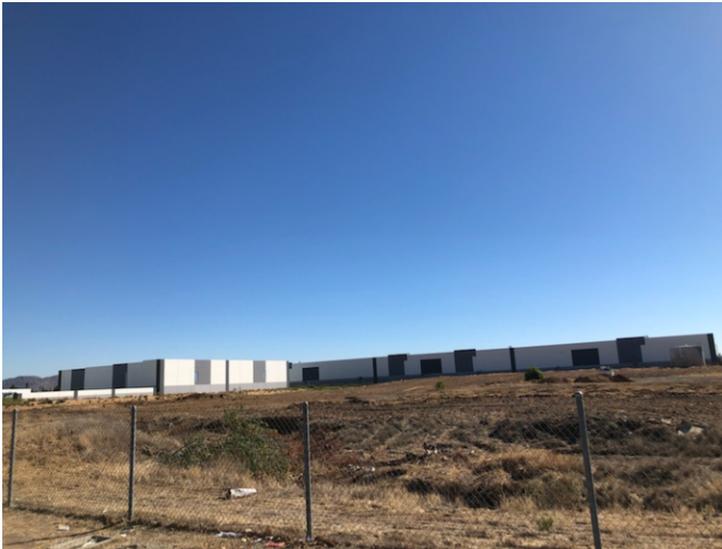
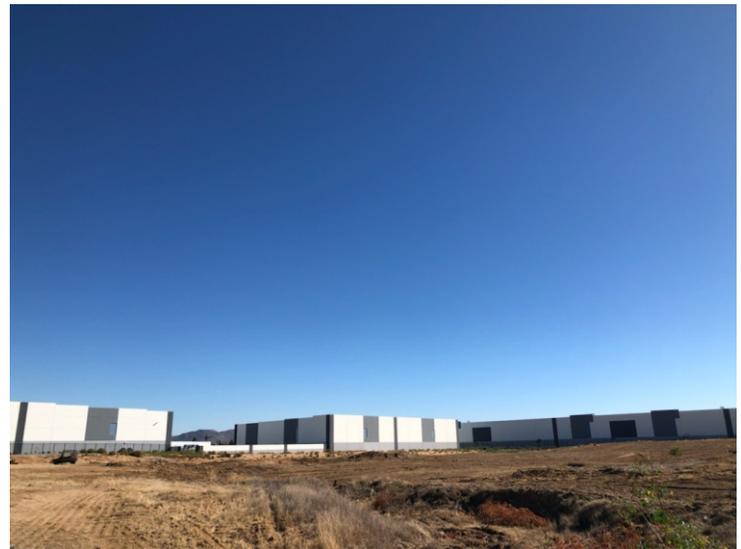
Source: LCG 10MV LLC.

Project site and vicinity land uses are denoted at Figure 2.3-1 and are described below. Representative photos of the Project site are presented at Figure 2.3-2.

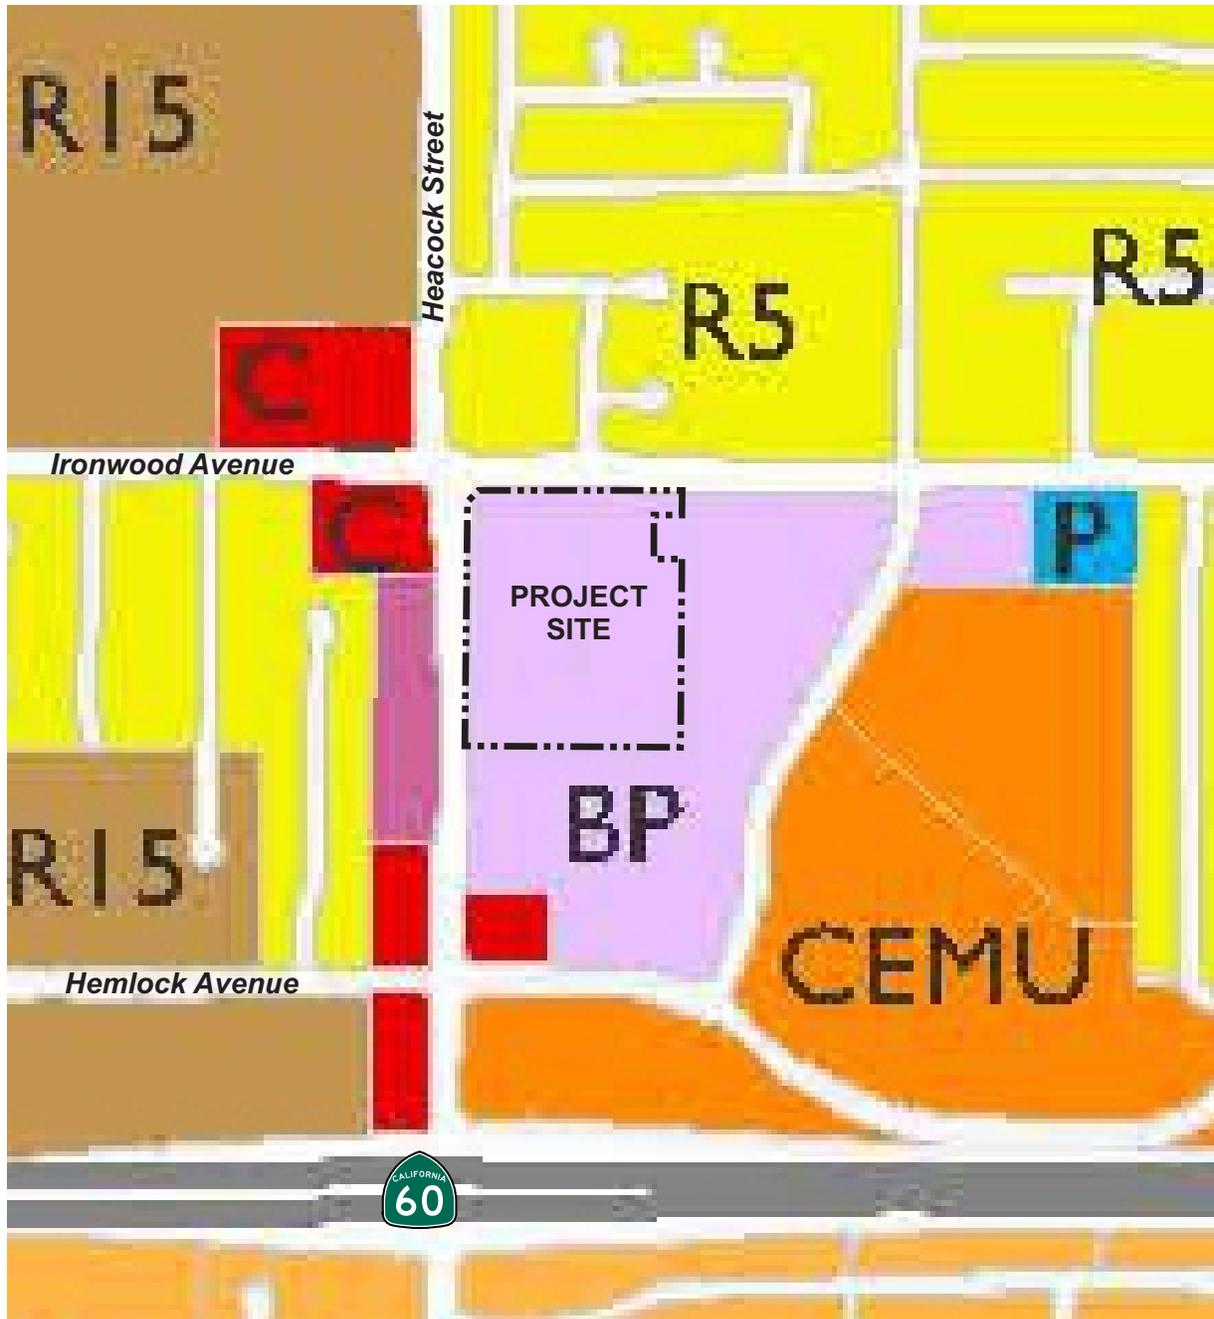
Figure 2.3-3
 General Plan Land Use Designations

Residential

- R5 Residential
- R15 Residential

General Plan Land Use and Zoning designations for the Project site and vicinity properties are depicted at Figures 2.3-3 and 2.3-4, respectively. The General Plan Land Use Designation of the Project site is “Business Park/Light Industrial.” The Project would be allowed under the Business Park/Light Industrial General Plan Land Use designation. More specifically, as described in the General Plan, “[t]he primary purpose of areas designated Business Park/Industrial is to provide for manufacturing, research and development, warehousing and distribution, as well as office and support commercial activities. The zoning regulations shall identify the particular uses permitted on each parcel of land. Development intensity should not exceed a Floor Area Ratio [FAR] of 1.00 and the average FAR should be significantly less . . .” (City of Moreno Valley General Plan, p. 2-14).

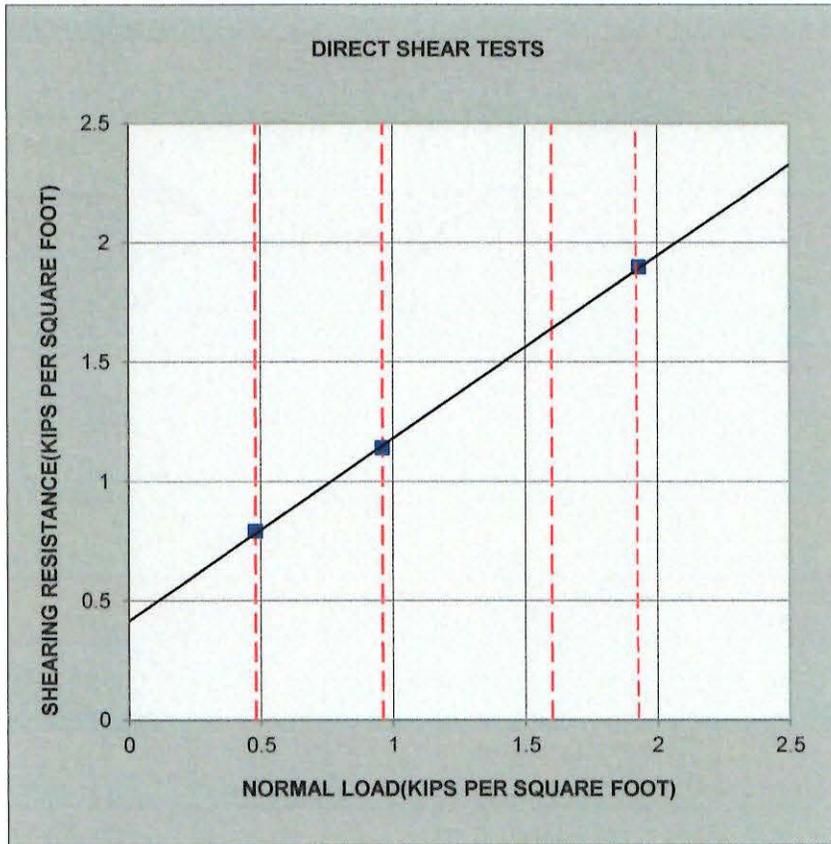
SYMBOL	LOCATION	DEPTH (FT)	TEST CONDITION	COHESION (psf)	FRICTION (degree)
■	B-1	3 to 5	Remolded to 95%	415.54	37.44
Proposed Industrial Warehouse 75542 Heacock St. @ Ironwood Avenue Moreno Valley, California				PROJECT NO.	20022-F
				PLATE	B-1

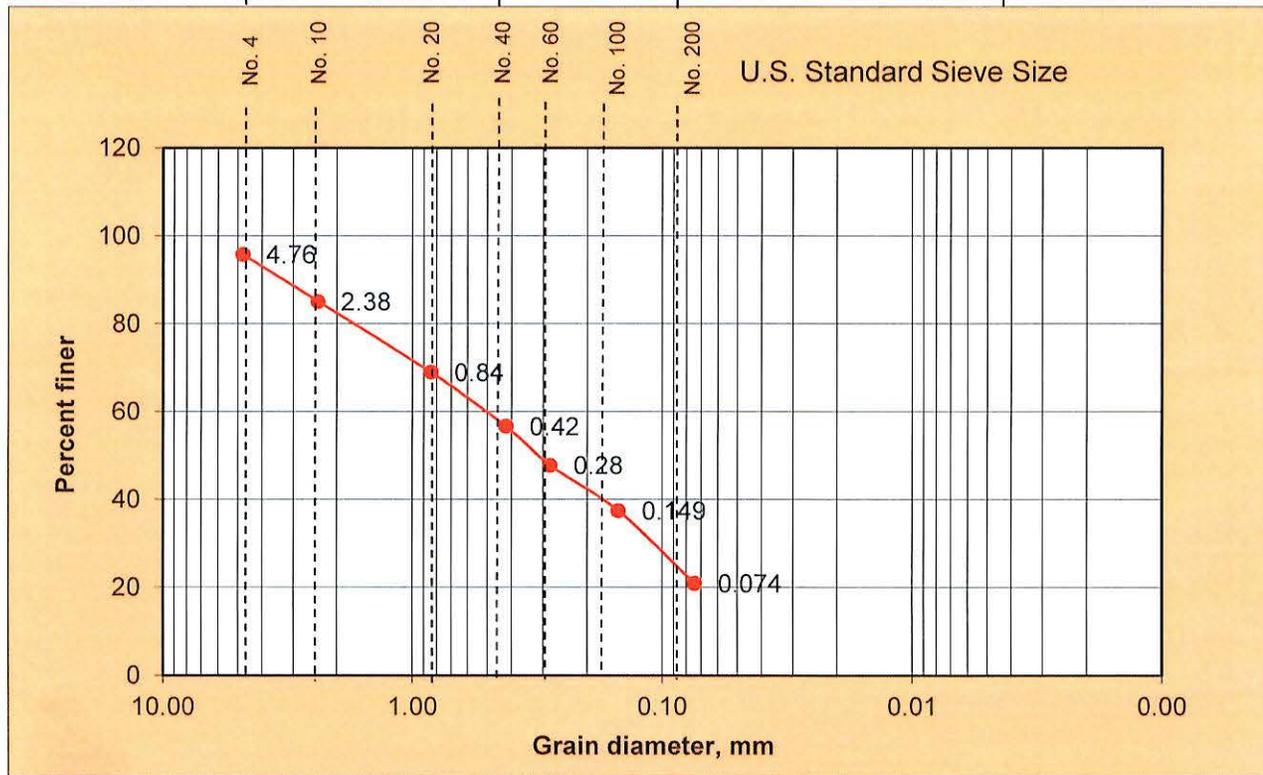
Sieve No.	Sieve Openings in mm	Percent Finer	Grain Size	% Retained
4	4.76	95.88	Gravel	4
10	2.38	85.12	Med. to Crs	39
20	0.84	69.06	Fines	32
40	0.42	56.72	Silts	25
60	0.28	47.82	Clays	0
100	0.149	37.52		
200	0.074	21.00

Visual Soil Description : Sand - fine to medium coarse

Soil Classification: SM

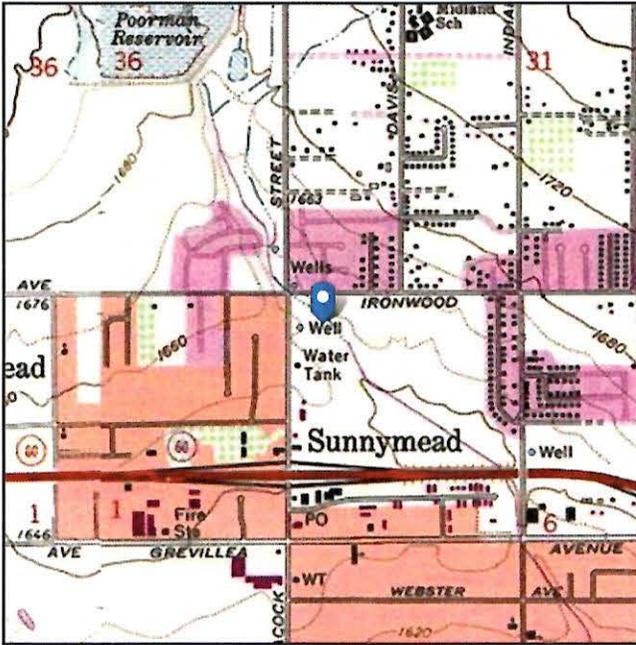
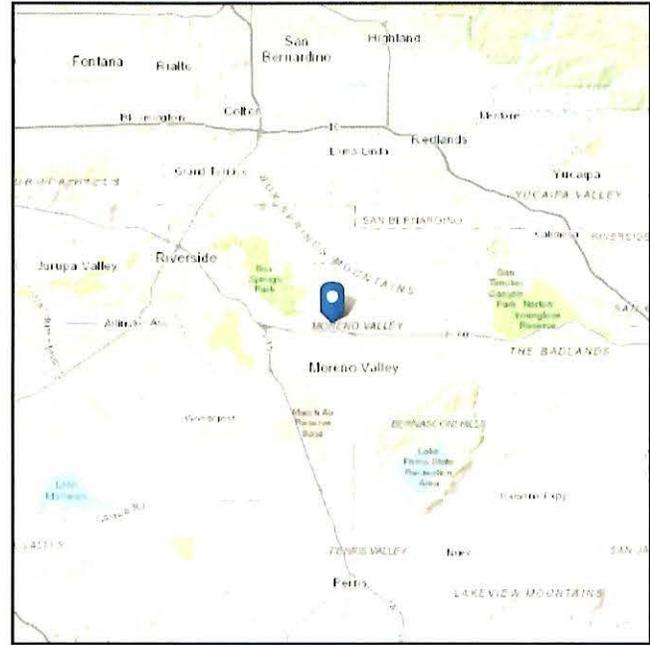
Standard: ASCE/SEI 7-16
Risk Category: III
Soil Class: D - Stiff Soil

Elevation: 1651.21 ft (NAVD 88)
Latitude: 33.945626
Longitude: -117.242573

Site Soil Class: D - Stiff Soil

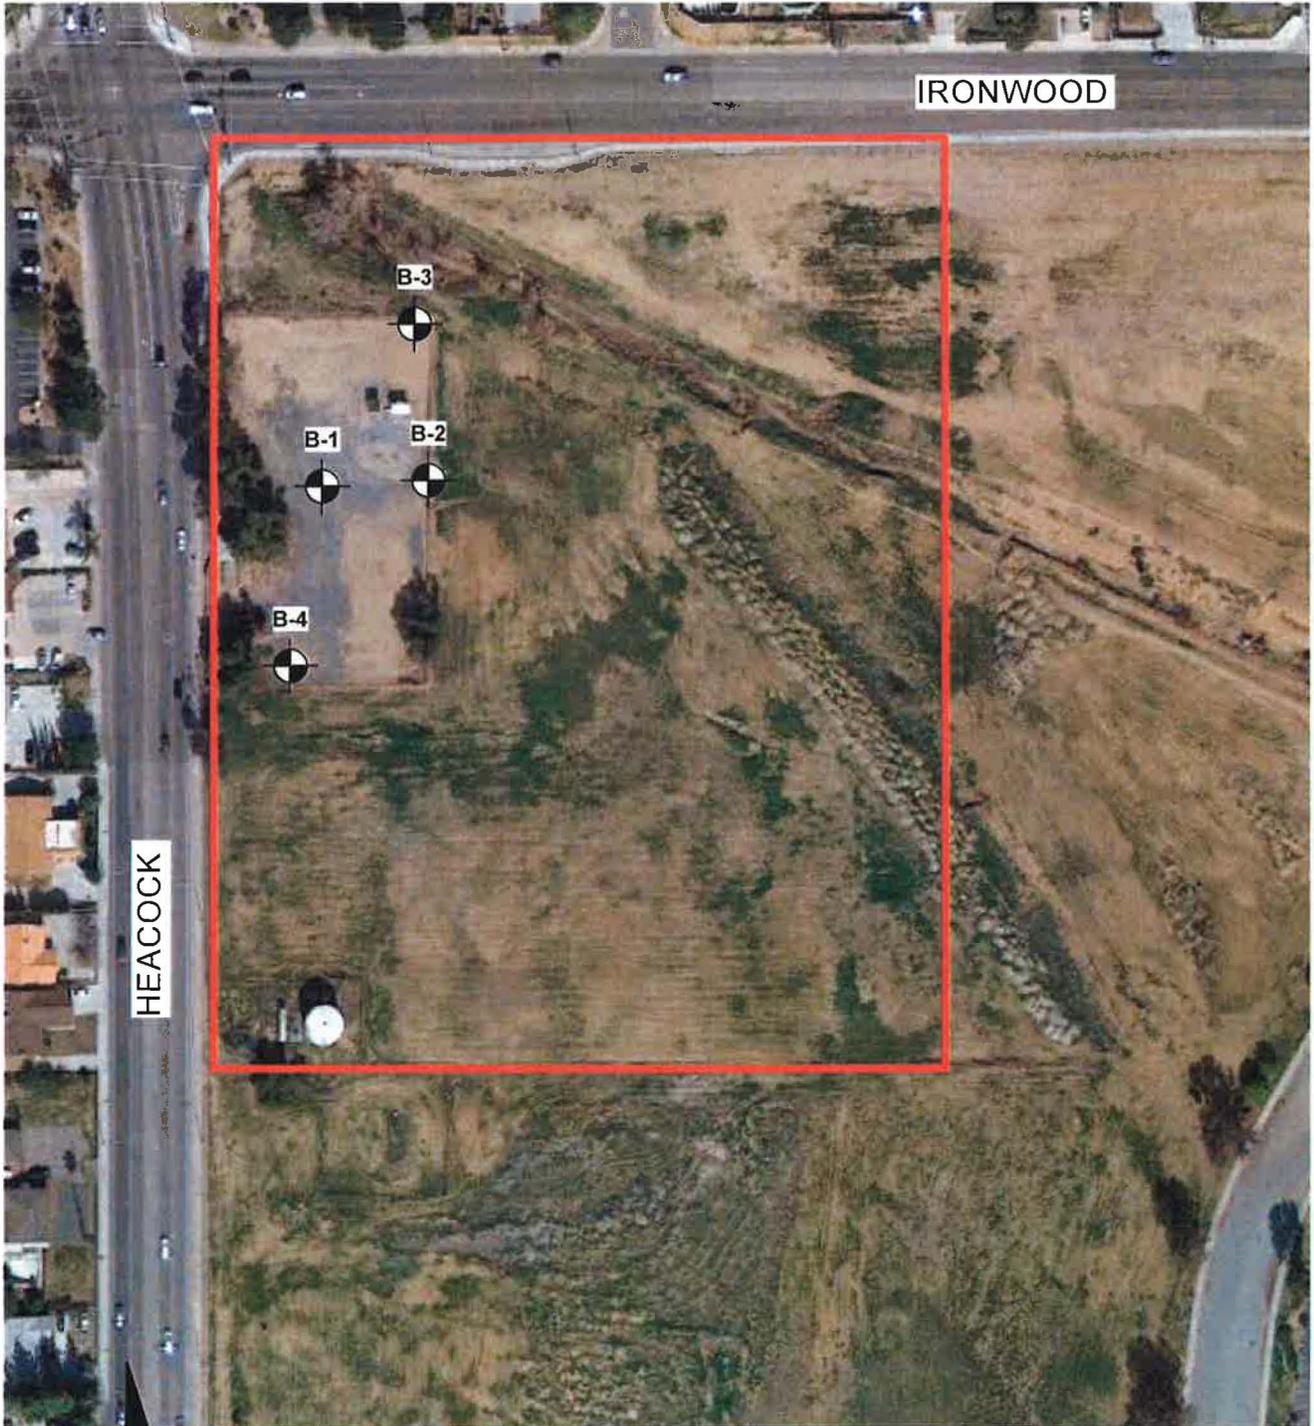
FIGURE 2

HEACOCK

IRONWOOD

We performed four exploratory borings at the site to evaluate subsurface conditions at the site. The approximate locations of the borings are shown on the Site Plan, Figure 2. The borings were drilled to depths of 21 feet below existing grades. Logs of Borings are presented in the Appendix A.

The subsurface conditions at the site were investigated by drilling and sampling four exploratory borings. The borings were advanced to depths of 21 feet below the existing ground surface. The locations of the explorations are shown on the Site Plan, Figure 2.

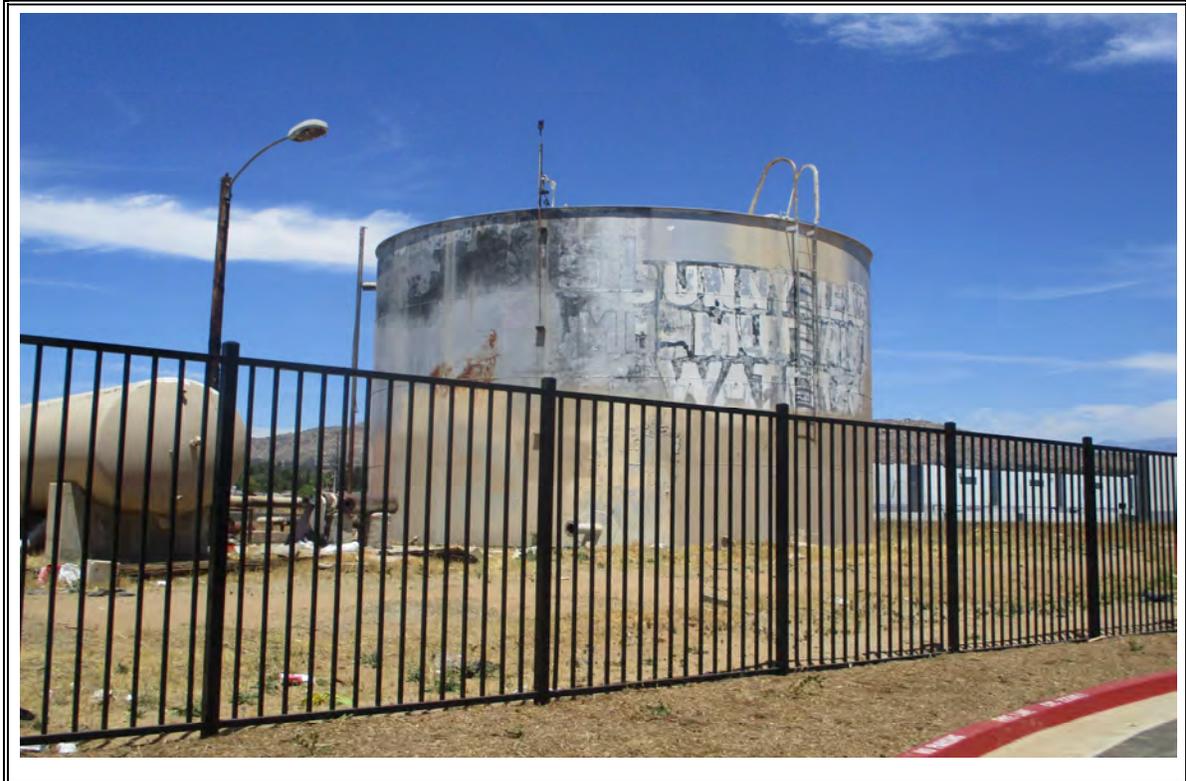
6. View of a former water AST on the southwest portion of the Site.

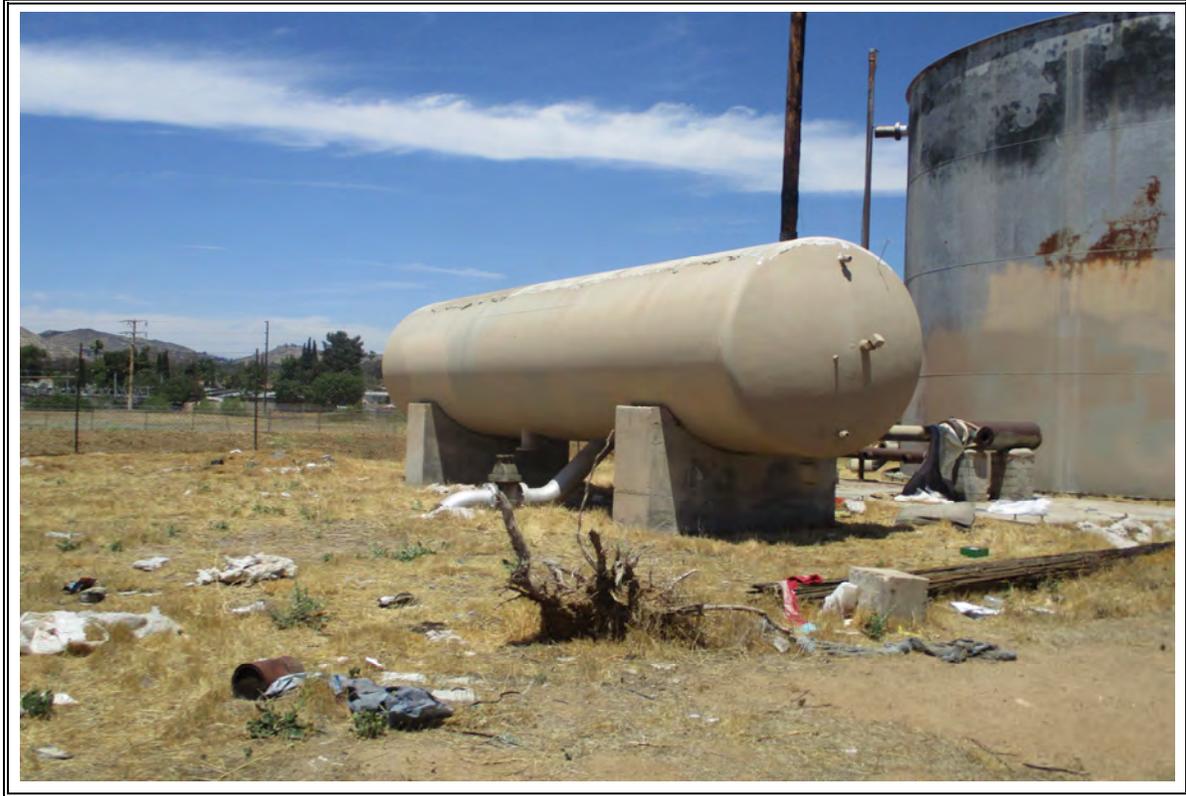
7. View of an AST on the south portion.
